NAVAL MEDICAL RESEARCH INST BETHESDA MD
OPERATION SNAPPER, NEVADA PROVING GROUNDS, APRIL-JUNE 1952, PRO--ETC(U)
DEC 52 R H DRAEGER, M EICHER, T S ELY

AEC-WT-527

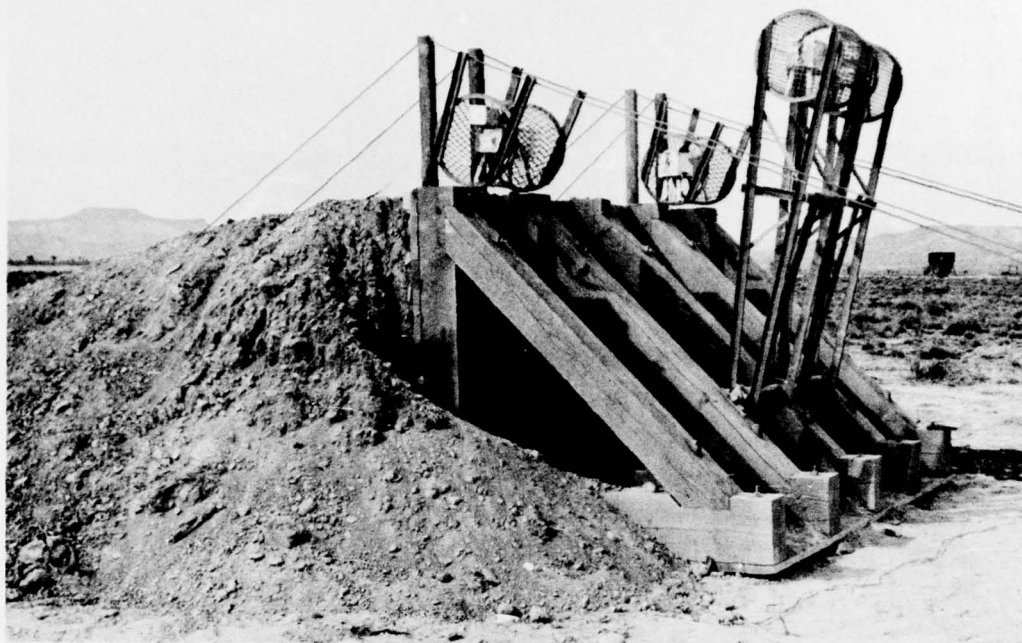
Fig. 1.1 Blast Barrier with Open Mesh Blast Exposure Cage, Side View

18 inches and length of 22 inches. The ends were reinforced by 1 x 2 inch steel channel welded to the wire mesh, one end having an 11 x 14 inch door.

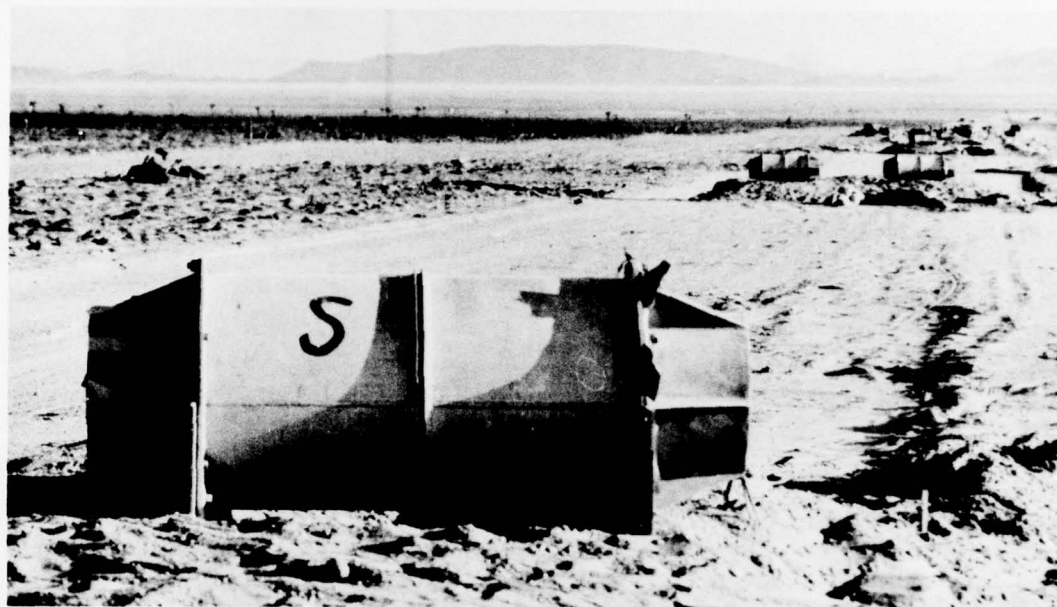
Fig. 1.3 Cylindrical Blast Exposure Container

having a width of 6 inches, and length 19 inches. The body was provided with a hinged cover and divided into three compartments. Accelerometers were placed in the central compartment, and sufficient lead shot in the end compartments to increase the total weight to 30 pounds. The outside surface of the mock dog was covered with aluminum foil to minimize thermal damage. Twenty-four of these dogs were provided.

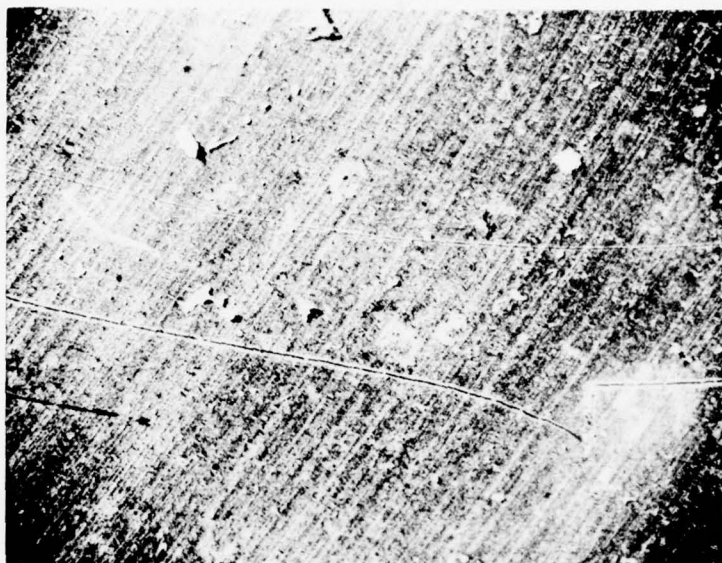
Fig. 1.15 Photomicrograph of Air Pressure Changes Mechanical Clock Recorder No. 12, 1114 Feet Ground Range, Shot 3, about 21x

Fig. 1.16 Photomicrograph of Air Pressure Changes Mechanical Clock Recorder No. 1, 1913 Feet Ground Range, Shot 4, about 21x.

Fig. 1.17 Photomicrograph of Air Pressure Changes Peak Pressure Recorder No. 212, 2796 Feet Ground Range, Shot 4, about 21x

Fig. 1.18 Photomicrograph of Air Pressure Changes Mechanical Clock Recorder No. 10, 1682 Feet Ground Range, Shot 3, about 108x

In Shot 3 all pressure recorders were recovered undamaged from the five cylindrical exposure containers. The pressure data obtained are given in Table 1.3. In Shot 4 the first station was completely destroyed. The pressure recorders were recovered undamaged from the other four stations. The pressure data obtained are given in Table 1.4. Approximate phase relations for Shots 3 and 4 are given in Table 1.5. Selected photomicrographs of air pressure changes are given in Figs. 1.15 through 1.18.

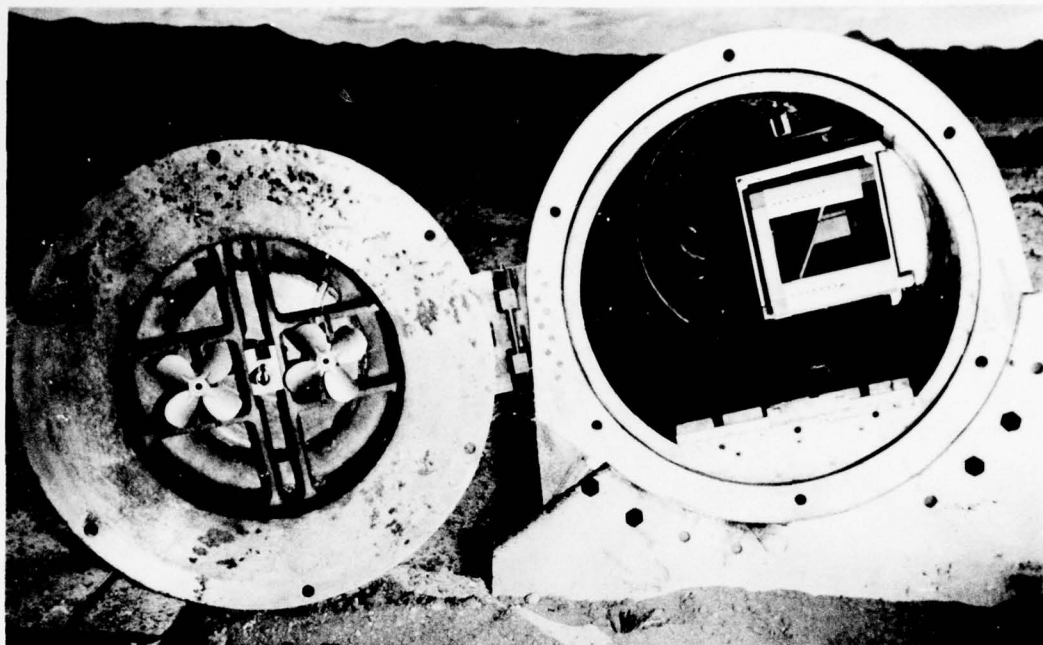
Fig. 2.8 Cylindrical Thermal Exposure Unit with Shutter Housings Open Showing Animal Container, Heater and Ventilation Fans

ventilation fans which maintained a moderate flow of air through the exposure container, Fig. 2.8.

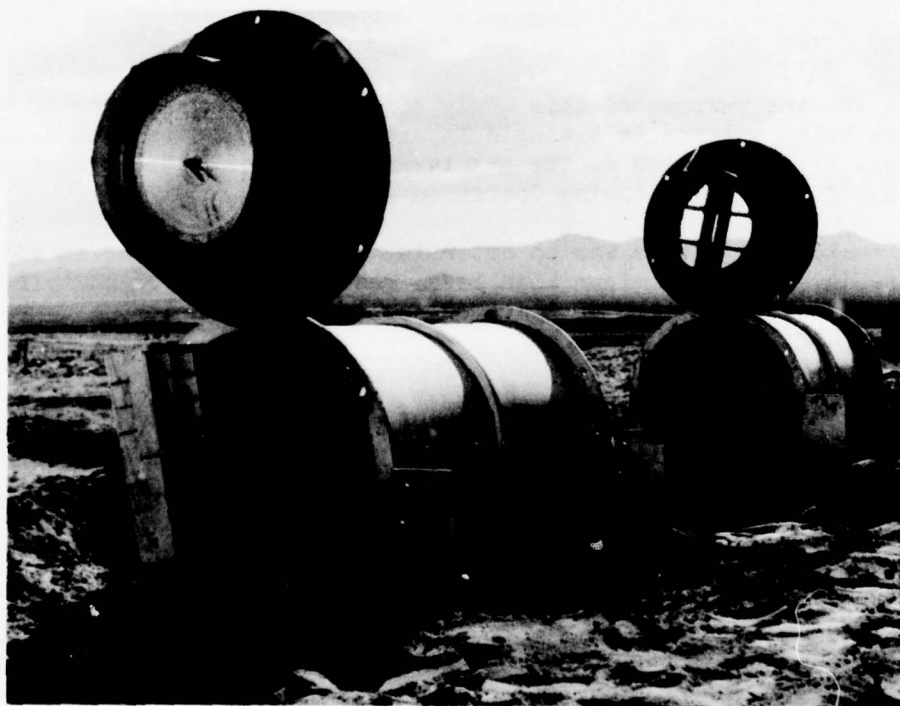
Fig. 3.1 Single Layer Multicompartment Mouse Cage Positioned in Animal Exposure Container

Operation GREENHOUSE cylindrical animal exposure containers mounted on timber skids as described in 1.4 were used for the exposure of single layered mouse cages, Fig. 3.1

These cages were constructed of 1/4 inch plywood having perforated metal covers. The cage was divided into 96 separate compartments arranged in eight rows and 12 columns each having inside dimensions of 2 x 2 1/4 x 3 inches.

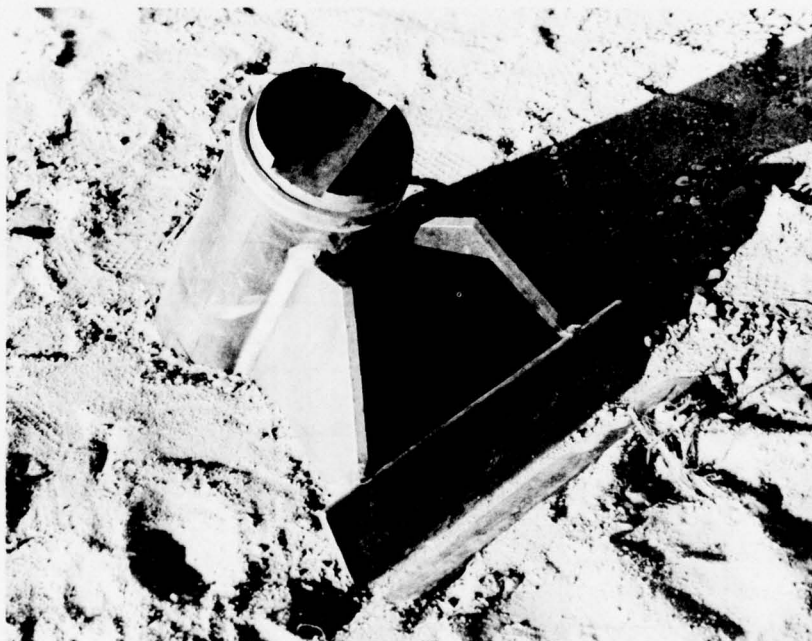
Fig. 3.2 High Level Radiation Exposure Container

In order to reduce the attenuation of radiation caused by the heavy steel walls of these containers they were redesigned and constructed entirely of aluminum. Vycor glass dosimeters were used to measure ionizing radiation.
